Is a Towering Inferno Possible in Ontario?

By Dale D. Kerr

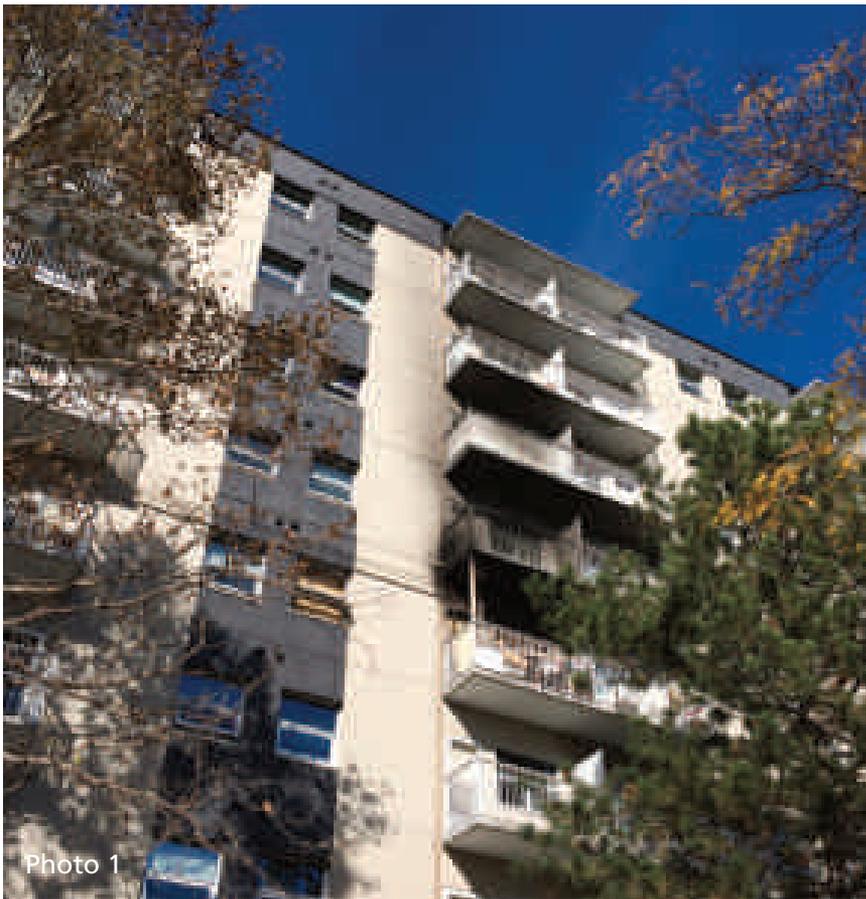
Photo 1

A building in Windsor, clad with EIFS, recently experienced an extensive fire within a suite on the fifth floor (Photo 1). A textured finish system (no insulation) was installed on the balcony walls and EIFS was installed on either side of balcony. The paint finish on the metal conduit beside the balcony burned off, there was smoke staining on the walls and balconies above the fire unit, but the encapsulated EPS insulation was contained and did not contribute to the spread of the fire (Photo 2).
